# Pilot Boarding Arrangements

**Common defects**

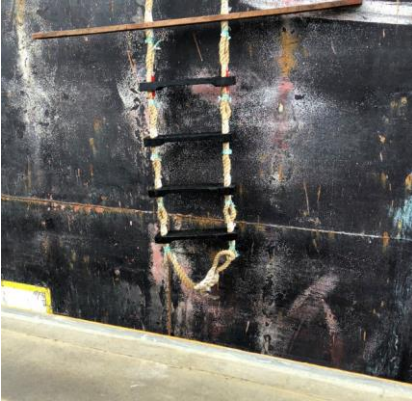
1. Loo under bottom step.

Increased risk of pilot ladder catching on pilot boat. Loop under bottom step not permitted.

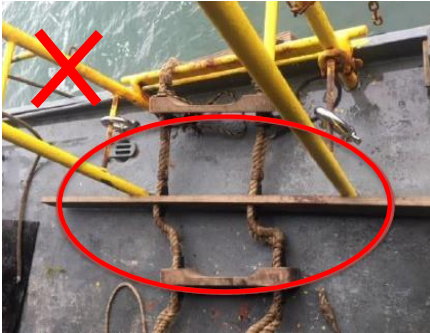
4. Spreader braced against stanchion.

Spreader not designed to take weight of pilot ladder. Spreader is only seized to side rope so should spreader, or wedges holding it fail, the ladder will drop.

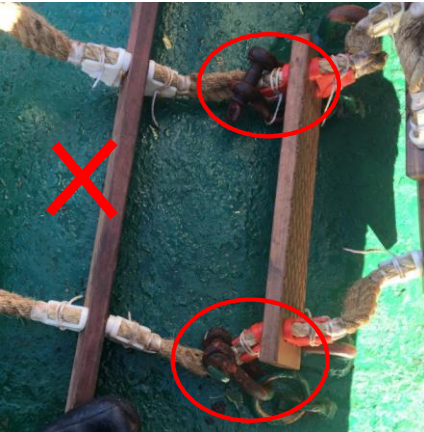
5. Step taking weight of ladder.

Step not designed to take weight of pilot ladder. Steps are only seized to side rope so should step, or wedges holding it fail, the ladder will drop, at least to the next step. The pilot ladder side ropes should be secured to a strong point (with rope of similar size/construction if pilot ladder is not of correct length).

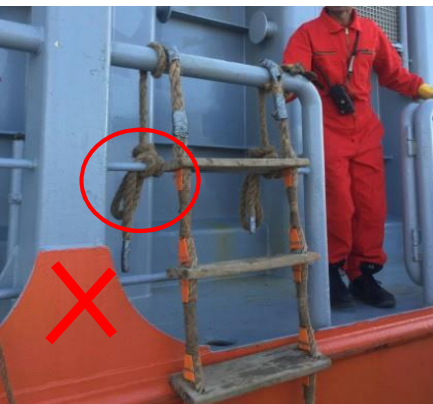
6. Pilot ladder secured to ship's rails.

Ladder to be secured to strong points.

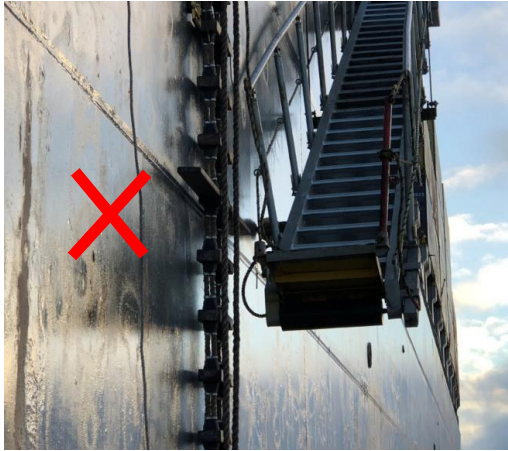
7. Accommodation ladder not secured to ship's side.

Accommodation ladder to be secured to ship's side.
